Corrective Color

Nawkaw Project Sheet

Fairview, Kentucky, USA

Color treating repaired concrete to blend with unaltered areas.

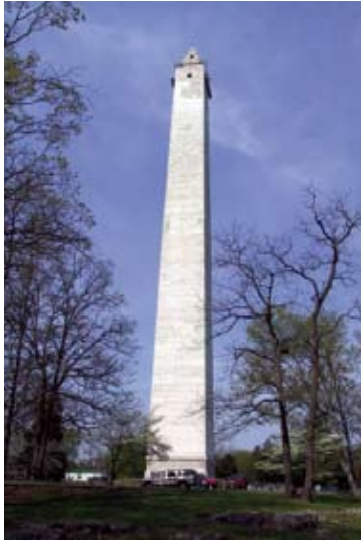
before

When restoring a concrete structure, its virtually impossible to match the colors exactly. Years of weathering will inevitably make unrepaired areas look different than repaired areas with an application of new concrete.

The Jefferson Davis Monument was built between 1917 and 1924 in Fairview, Kentucky. The monument is approximately 351 ft tall and was constructed as an unreinforced concrete obelisk with walls 7 ft, 8 in. thick at the base and 2 ft thick at the top. Deterioration of the unreinforced concrete was caused by cyclic freezing and thawing of saturated concrete.

The rehabilitation project was prompted by the continuing deterioration of the exterior facade and the safety hazard posed by falling concrete. The goal of the rehabilitation project was to repair the exterior concrete and reduce the rate of future deterioration.

The project included developing sample repair materials and procedures to match the original appearance. Concrete repair materials were placed using form and pour techniques, and were anchored to the original base mix concrete by embedded dowels.

When the material repairs were completed, Nawkaw was sub-contracted to stain the concrete, to help blend the new area with the existing surface. Nawkaw's NWRT 91 product was used to also provide crucial waterproofing characteristics for future weathering.

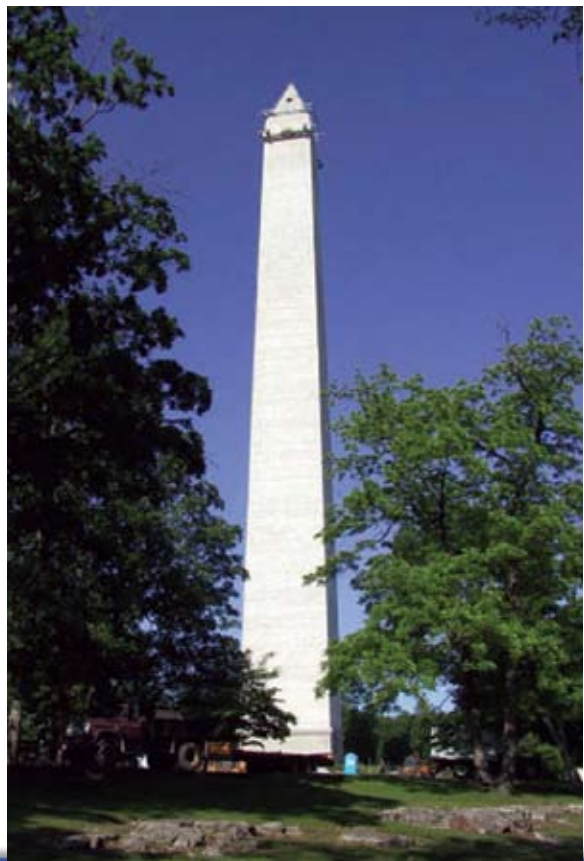
after
